LONGHORN ARMY AMMUNITION PLANT KARNACK, TEXAS

ADMINISTRATIVE RECORD

Volume 9 of 25

**PILOT STUDY IMPLEMENTATION PLAN
GROUNDWATER TREATMENT PLANT AND WELL FIELDS
LONGHORN ARMY AMMUNITION PLANT
KARNACK, TEXAS**

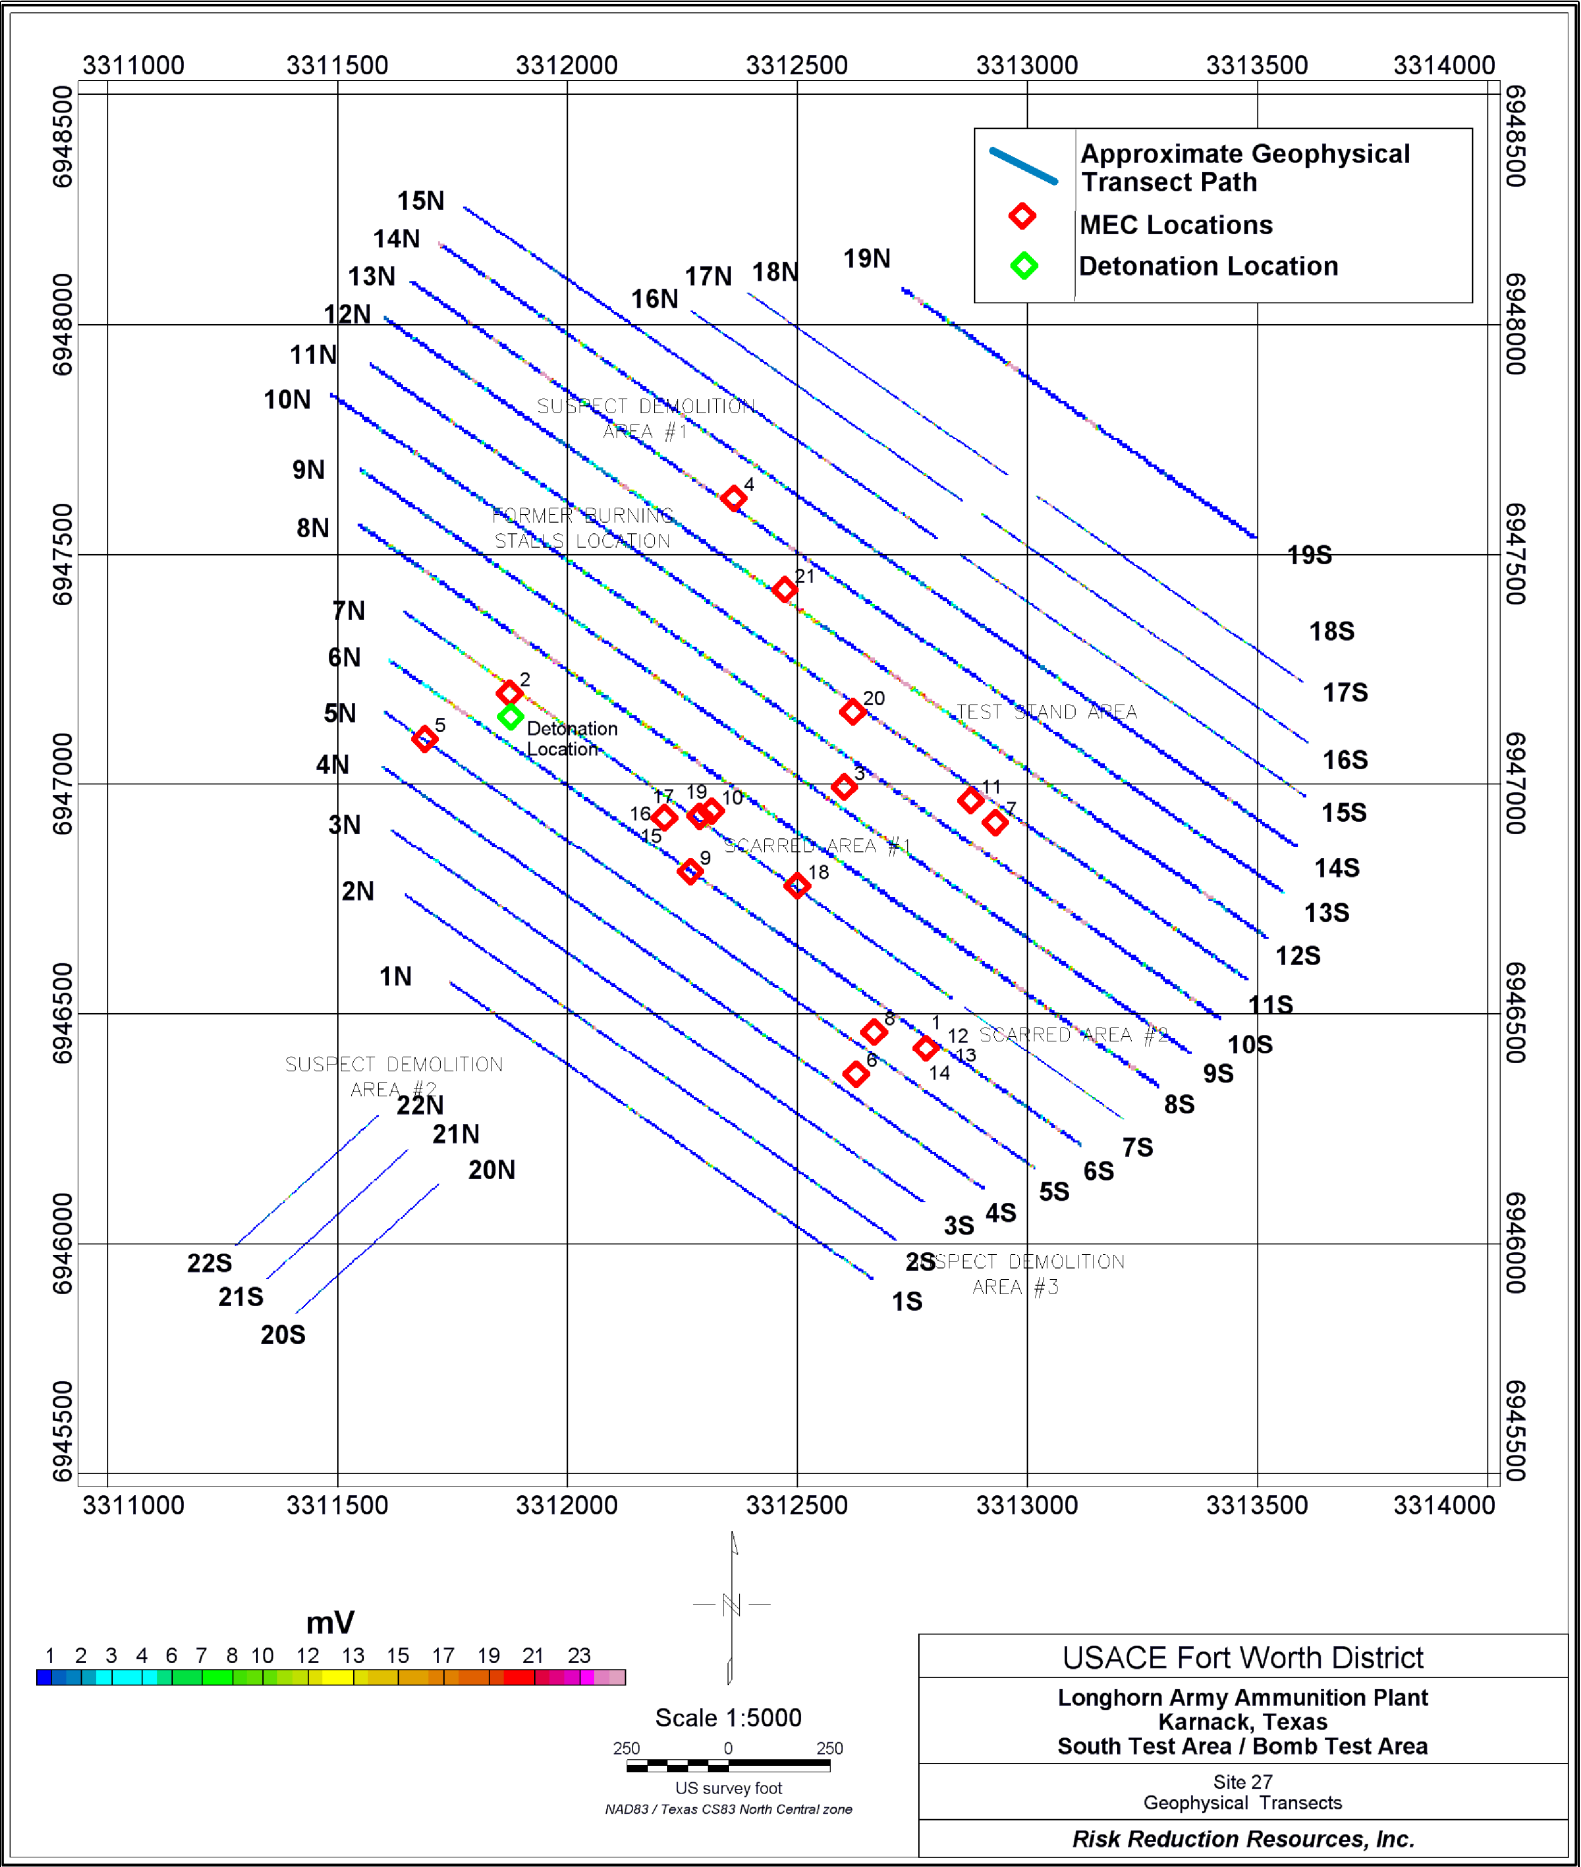
CONTRACT NO:	N/A
JOB NO:	42019.004.001
CHECKED BY:	R.VINSON
DRAWN BY:	E.B / C.RIOS
DATE:	MAY 2007
FILE NAME:	LNGHRRFIG4-1
SHEET NUMBER:	FIGURE 4-1

SOUTH TEST AREA/BOMB TEST AREA
SITE 27
RESPONSE/SIGNAL STRENGTH

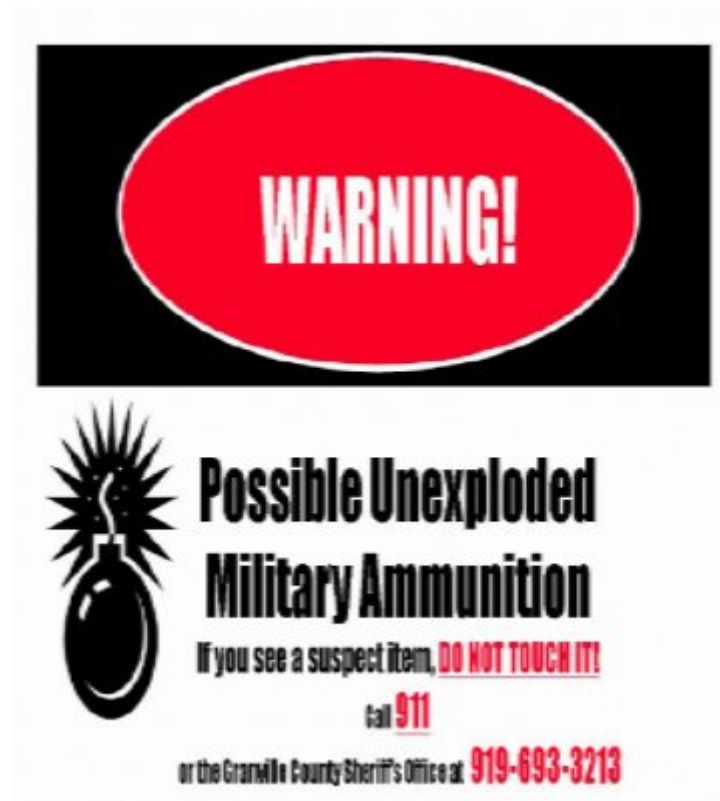
Figure 6-1: Example Warning Sign

Educational and notification programs are designed as an integral part of LUCs. Educational programs are intended to inform the public about the controls, how to identify hazards, and what to do if hazards are discovered. Informational pamphlets can warn the public of the hazards of ordnance based on the historical context of former operations that occurred at the LHAAP. An effective informational pamphlet contains photographs and/or drawings of typical ordnance items that the public might encounter and maps of previously recovered MEC site locations.
